# Recall Bulletin

File In Section: Product Recalls,  
Bulletin No.: 03004  
Date: February, 2003

**SUBJECT: 03004 - LEFT REAR DOOR UPPER HINGE WELD**

**MODELS: 2003 CHEVROLET TAHOE, SUBURBAN  
2003 GMC YUKON  
2003 CADILLAC ESCALADE  
BUILT AT ARLINGTON ASSEMBLY PLANT**

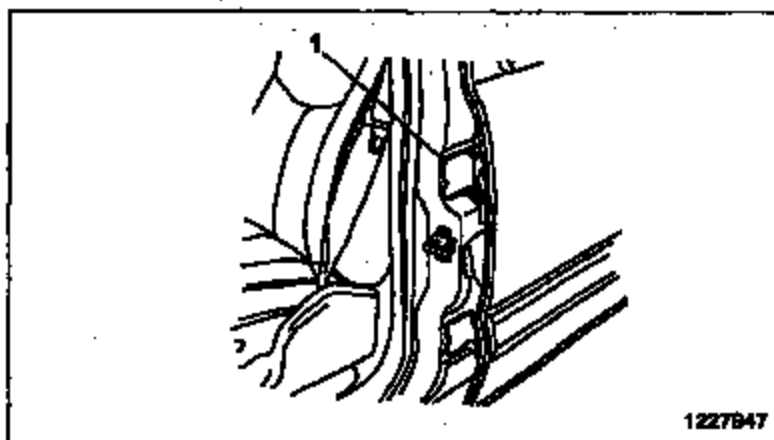
The following service procedure is for inspecting the welds that attach the left rear side door upper hinge (1) to the body "B" pillar sheet metal. If you find that the two rear welds are missing from the upper hinge, or smaller than the others, perform the repair procedure included.

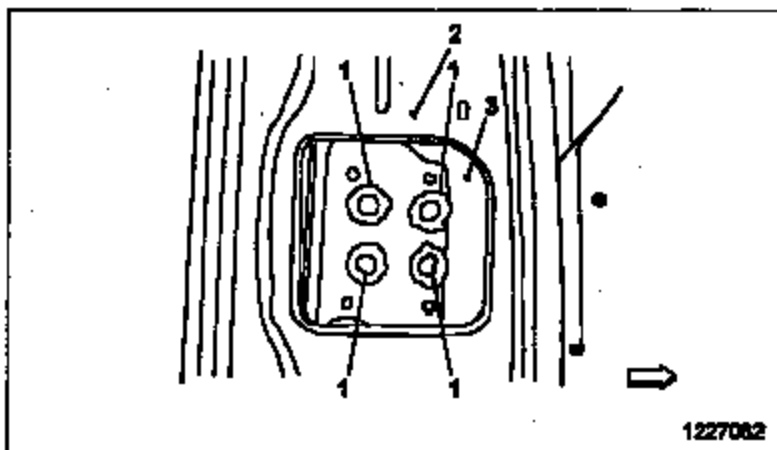
5. From inside the vehicle, look through the opening in the center pillar sheet metal directly behind the upper hinge.
- If there are four welds (1) present and ALL four are approximately the same size, NO repair is required. Proceed to step 14 to reassemble the vehicle.
  - If ONE of the REAR welds is missing, or is a lot smaller in size than the others, NO repair is required. Proceed to step 14 to reassemble the vehicle.
  - If TWO of the REAR welds are missing, or if the two rear welds are a lot smaller than the front welds, then a repair is required.

The next steps should only be performed if the two rear welds are BOTH missing or are a lot smaller in size than the others. Also, you only have to repair one of the two rear welds.

7. From inside the vehicle, center punch and drill a 1/8 inch pilot hole through the body sheet metal where one of the missing welds should be. If the welds are present, but just smaller in size, drill the hole directly through the center of one of the small welds. Continue drilling all the way through the hinge plate on the other side.
8. Using a 15/32 inch drill bit, increase the size of the hole to allow for the installation of the repair stud (bolt).
9. Remove any metal burrs or debris from the drilled hole. Touch-up the drilled hole as necessary using the information found in the applicable Service Manual and GM Refinish Material Booklet #4901M-D-2003 (English) or #4901M-D-F2003 (French).
